RE: Facility Inspection – Minor Deficiencies Noted  
Choctaw County Jail  
NPDES Permit ALR10C6W7  
Inspected 03/05/2026

Choctaw County Jail : V105-3YVR-20T  
FOD NPDES Construction Stormwater Inspection Form

| Water Division Permit Detail | |
|---|---|
| Site Name: | Choctaw County Jail |

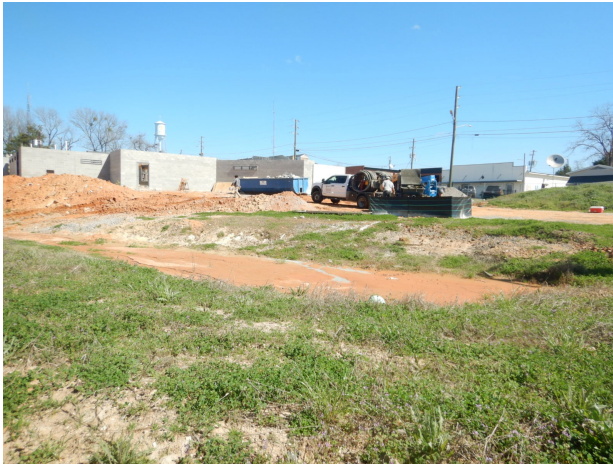
Photo Taken: 03/05/2026 11:42:40 AM  
GPS Latitude: 32.0879833333333  
GPS Longitude: -88.223035

Exposed slopes not fully protected.

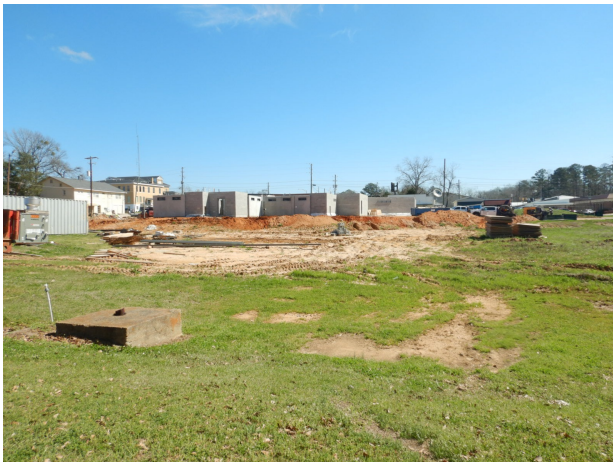
Photo Taken: 03/05/2026 11:43:59 AM  
GPS Latitude: 32.087855  
GPS Longitude: -88.2229583333333

Exposed slopes not fully protected.

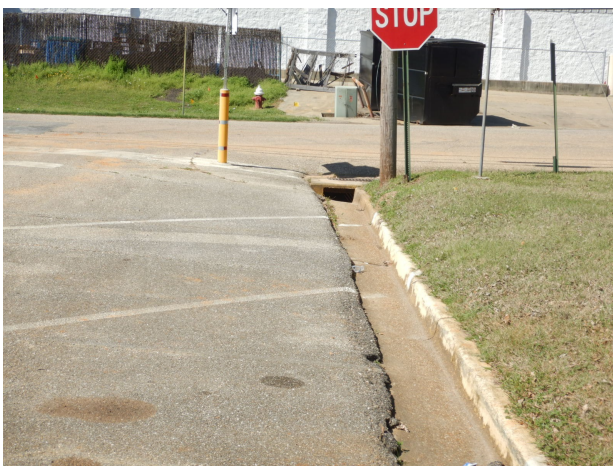
Photo Taken: 03/05/2026 11:44:43 AM  
GPS Latitude: 32.0883833333333  
GPS Longitude: -88.2235466666667

No inlet project observed downhill of project entrance.

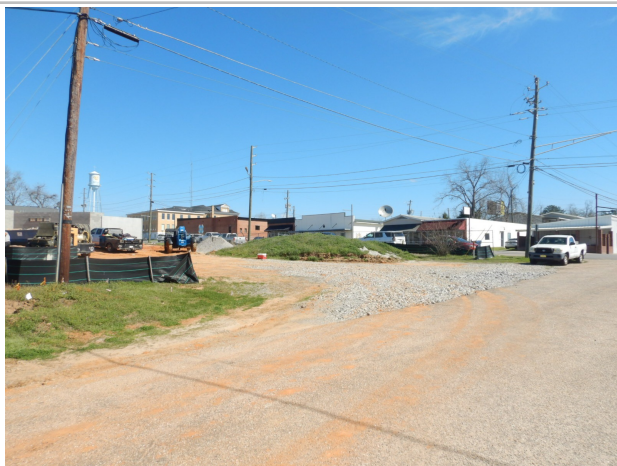
Photo Taken: 03/05/2026 11:41:59 AM  
GPS Latitude: 32.0339516666667  
GPS Longitude: -88.2743116666667

Construction exit pad not properly installed and/or maintained. Sediment tracking observed in street.

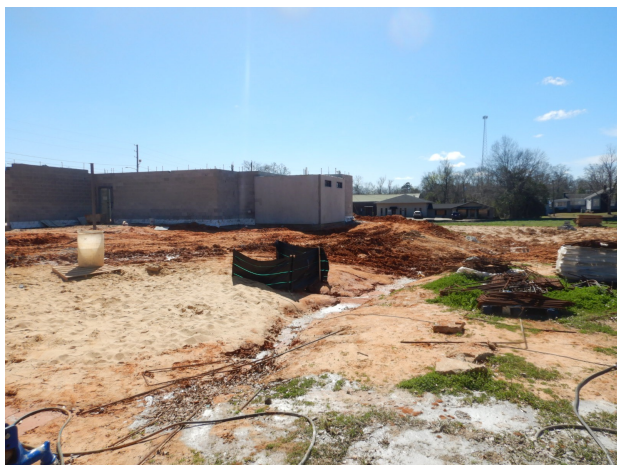
Photo Taken: 03/05/2026 11:45:09 AM  
GPS Latitude: 32.0887433333333  
GPS Longitude: -88.2232016666667

Exposed slopes not fully protected. Concrete wash material not properly disposed of.
